NIOSH
Fire Fighter Fatality Investigation
and Prevention Program

A summary of a NIOSH fire fighter fatality investigation

Volunteer Deputy Fire Chief Dies after Falling Through Floor Hole in Residential Structure during Fire Attack—Indiana

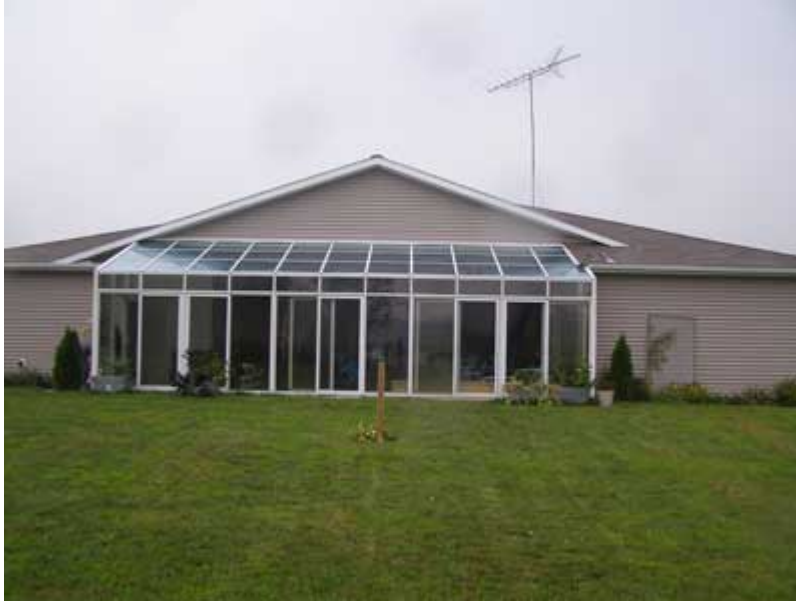
Photo 1: Side-C of the structure. Photo courtesy of the fire department.

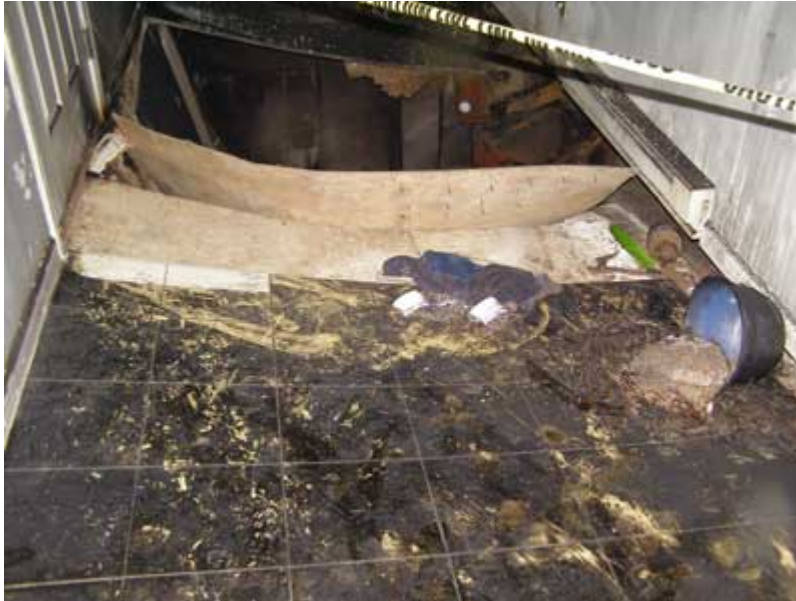
instructed FF#1 to stretch the additional line around to the B-side to hit the fire in the basement through a window (*Note: the basement window led to a crawl space, so no water actually hit the basement, or the fire*). Also, during this time, FF#2 set up a positive pressure ventilation (PPV) fan at the entrance on side A. The victim stayed at the front entrance (alone a second time) to reportedly attack the fire through the hole in the floor just to the left of the entrance (see [Photo 2](#) and [Figure 2](#)).

Photo 2: Depicts the failed floor from above. Note the front door in the upper left-hand corner. Photo courtesy of the fire department.

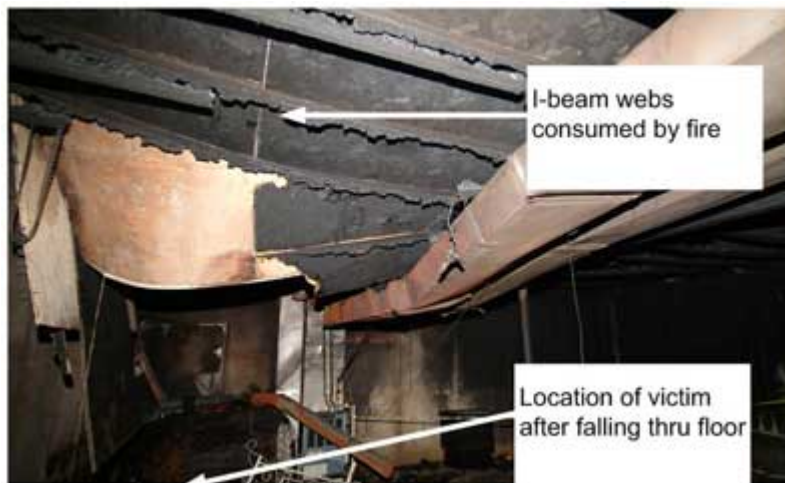
Around this time, the Assistant Chief arrived on scene in E-406, along with one fire fighter, but did not assume IC. As the Assistant Chief made his way to A-side of the structure, he saw a hose going down through a hole in the floor just inside the main entrance (see [Photo 3](#)). He yelled down into the hole and heard a muffled reply. He could not hear what the victim was saying, so he turned down the positive pressure ventilation (PPV) fan and then very clearly heard the victim yell for help (*Note: it was stated by the Assistant Chief that the clarity of the victim's voice indicated that he had apparently taken his SCBA mask off to communicate*). The Assistant Chief immediately called to E-402 for a 14' roof ladder to be placed into the hole in the floor. At this time, FF#1 returned to A-side and started to slide down into the hole (prior to the ladder being placed) to try to retrieve the victim.

Photo 3 illustrates the floor failure area, viewed from the basement. Photo courtesy of the fire department

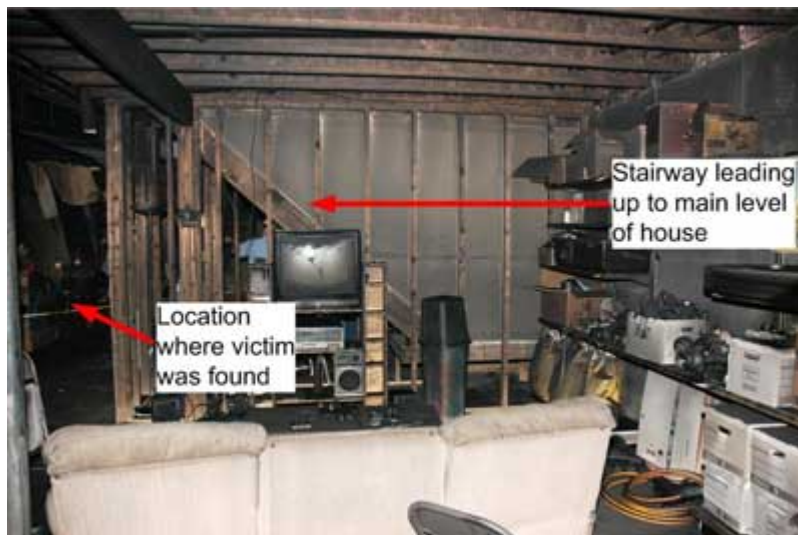
Photo 4: Basement layout showing stairway to main level of house.

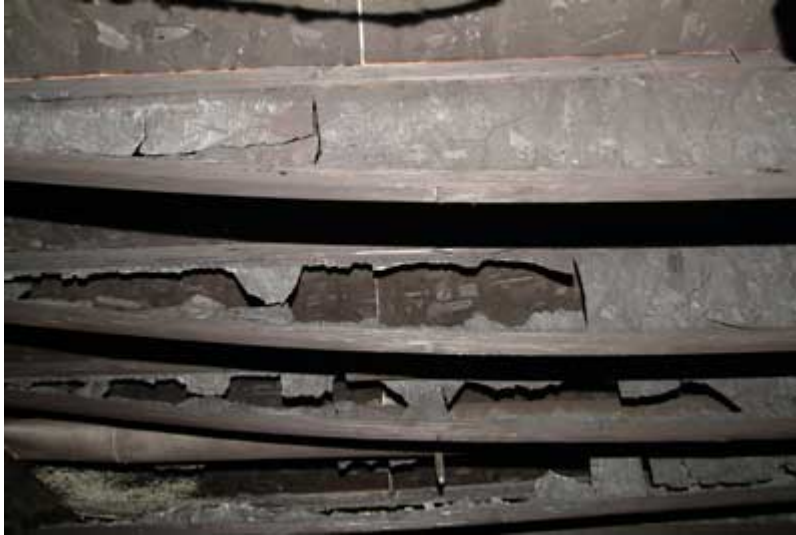
While objective time-to-failure studies of the various lightweight flooring systems being used today have been conducted only in limited cases, evidence from two FFFIPP investigations suggest and seems to support the fact that engineered I-joists quickly lose strength and integrity when damaged and weakened by heat exposure and flame impingement. (Photo 5) Often, the weakened I-joists can be difficult to detect from above as the floor surface above may still appear intact. Fire fighters who operate on floors above fire-damaged engineered I-joists may fall through the weakened floor and become trapped in the fire below. Incident commanders and fire fighters should be aware that these members can fail quickly and without warning, and they should plan interior operations accordingly.

Photo 5: Depicts the significant damage suffered by the webbing of the I-joists as compared to the flanges. This damage resulted in floor instability and failure. Photo courtesy of the fire department.

Recommendation #1: Fire departments should ensure that fire fighters and incident commanders are aware that unprotected pre-engineered I-joist floor systems may fail at a faster rate than solid wood joists when exposed to direct fire impingement, and they should plan interior operations accordingly.
